HARRIS POND DAM

NH 00122

PHASE I INSPECTION REPORT  
NATIONAL DAM INSPECTION PROGRAM

FEBRUARY 1979

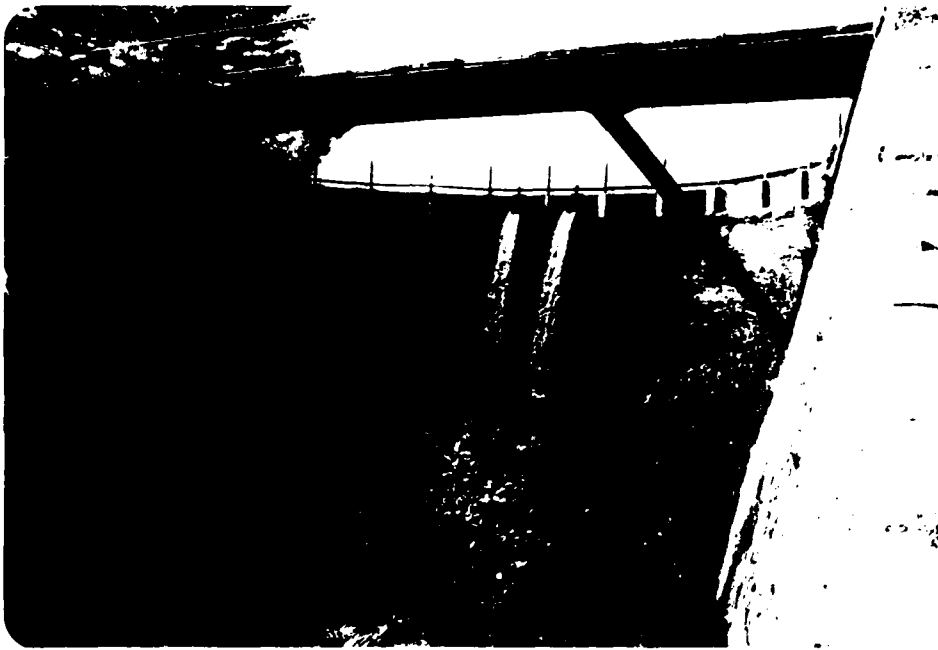
Overview of dam from downstream channel

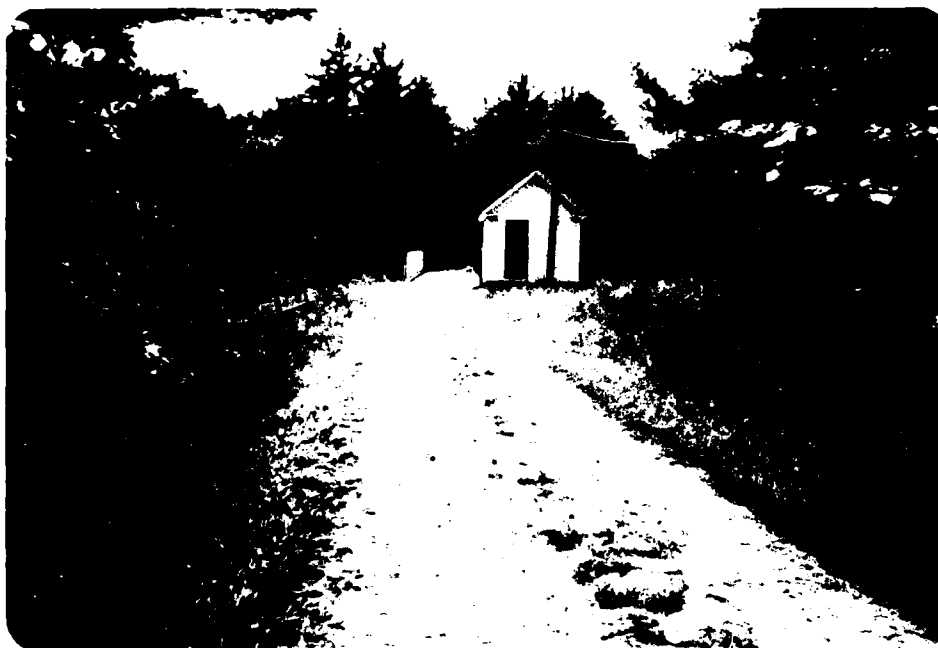
Overview of top of dam from left abutment

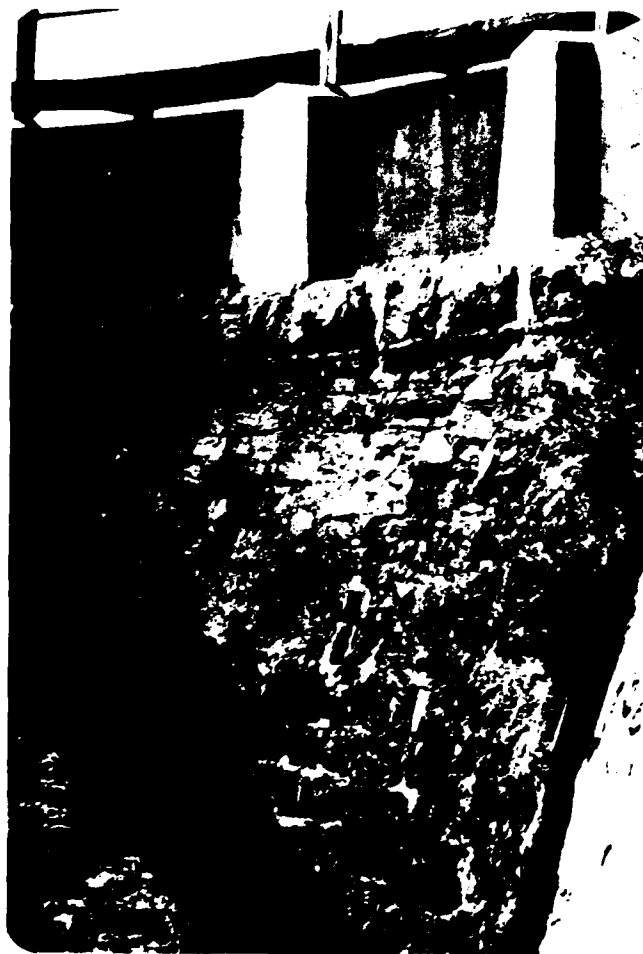
Observations of the cemented stone arch type spillway with its 2.9 foot high concrete cap have revealed seepage between the bottom of the concrete cap and the top of the cemented stone masonry. In some instances there is seepage through the open joints of the stone masonry. It is estimated that at least 50% of the joints in the spillway are void of mortar. The condition of the concrete cap of the spillway is good. The sluice gates are well maintained. The catwalk around the perimeter of the spillway is in good condition. This catwalk is not a debris catcher. The two-inch P.V.C. water pipe which is used to aerate the reservoir surface to prevent ice build up is broken and separated adjacent to the left abutment.

2. View from left downstream training wall of leakage between top of original dam and newer concrete spillway

The Harris Dam is in FAIR condition at the present time. This structure requires repointing of the open joints on the downstream face of the spillway and training walls and positive measures to control seepage through the right embankment to ensure its long-term safety and use.

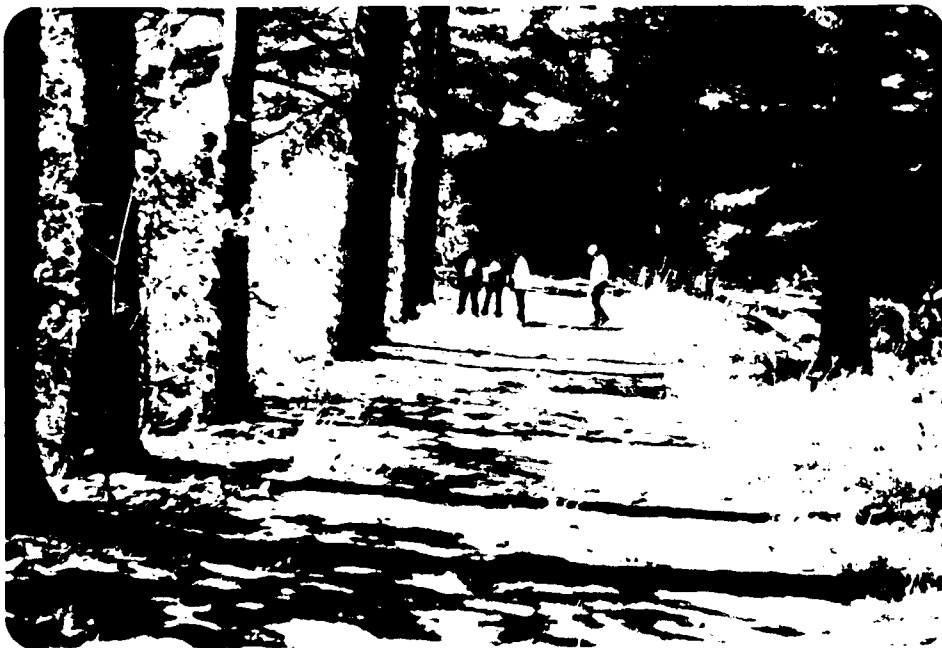
3. View of dike on right side of reservoir to fill in natural low area
